EXTRALUM

Technical Bulletin.

Spontaneous Breakage of Tempered Glass.

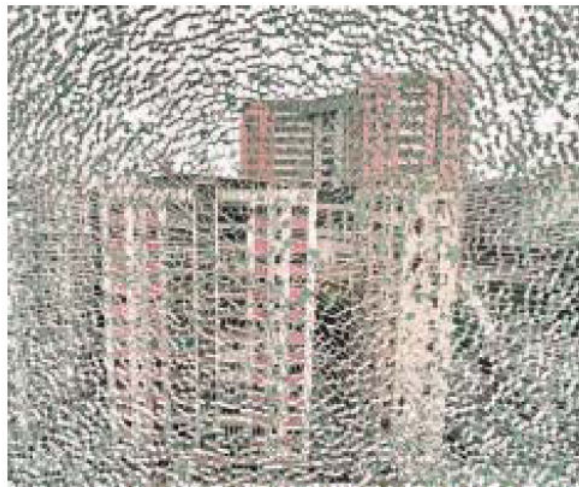
Circumstantially there are known cases in which tempered glass "exploded without any external intervention, for no apparent reason" (see [Figure 1](#)) and although it is unusual, this is possible and has clear and documented scientific and technical reasons. The phenomenon is known as *spontaneous Breakage of Tempered Glass*.

[Image 1](#). Typical break pattern by spontaneous breakage.

A good design should recognize this fact and specify the use of tempered glass in applications where spontaneous breakage does not cause major safety and functionality problems. Architects and engineers can minimize the risk of serious problems due to spontaneous breakage by recommending heat-strengthened glass and laminated glass in critical applications.

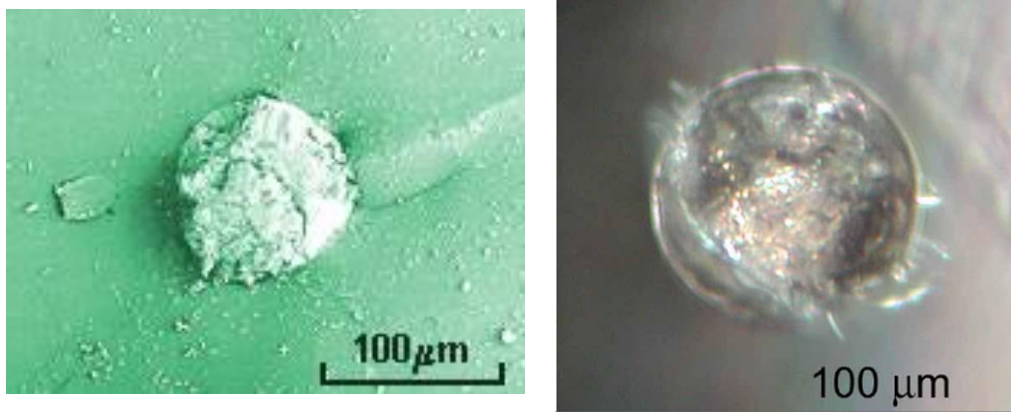
In the tempering process, rapid cooling (thermal shock) traps NiS inclusions in their compressed phase. Without no advice, these inclusions can return to their original state (expand), in a transformation that can increase their volume by up to 4%. When inclusion is in the central stress area of tempered glass, this increase in volume could cause a sufficient stress increase (tension) to break the glass.

Spontaneous breakage in tempered glass can happen at any time, without the need to apply a load or tension, in the short term or even five or ten years after manufacture. These inclusions are so small (about 0.03mm in diameter, see [Figure 2](#)) that, in practice, they are impossible to locate and identify them in the glass before or after the tempering process.

[Image 2](#). Two cases of inclusion of NiS particles.

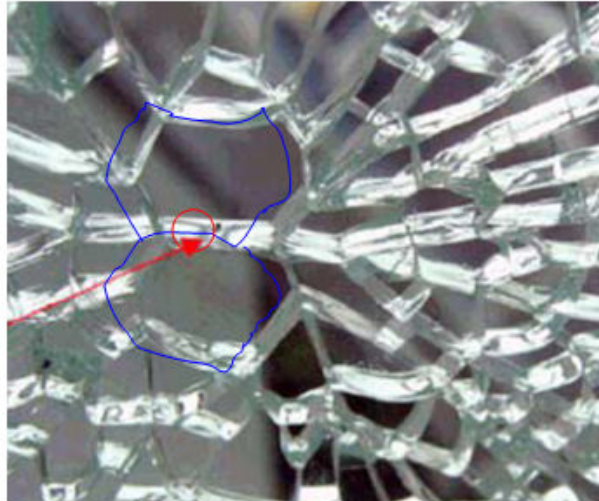
The use of state-of-the-art technologies such as the visualization of spontaneous breakage processes using electron microscopes allowed to discover indirectly the presence of these particles, exactly in the center of the fracture, with typical "butterfly" pattern. (see [Figure 3](#)).

Image3. Typical pattern of spontaneous “butterfly” breakage and the monolithic silicon particle, which generates the explosion

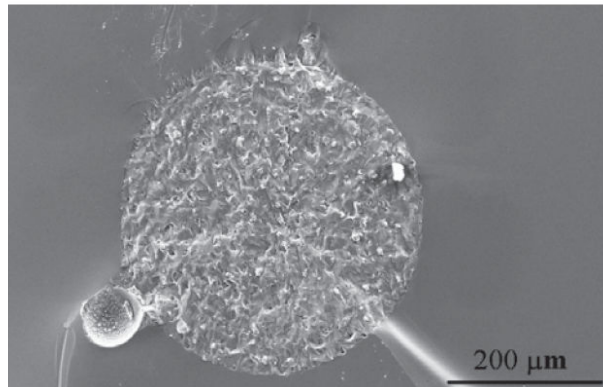
The expansion coefficient of monolithic silicon particles is twice as large as that of the tempered glass matrix, so the expansion phenomenon described above for NiS occurs equivalently. They have an average dimension of 0.3mm and under the electron microscope they are visualized as in Image 4:

Image4. Silicon monolithic particle.
